MORTAR & STEEL

Katie Worthington outlines techniques for fixing fine stone carving repairs

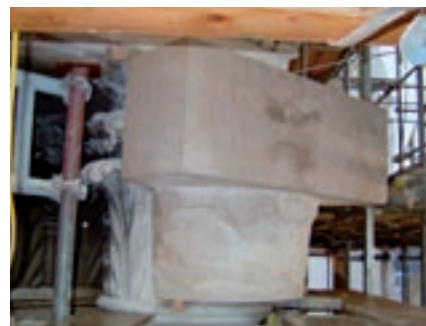
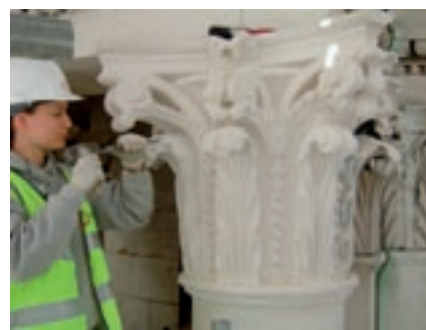
Top, detail showing the horizontal notch at the back of the opening and, middle, the new stone fixed in position pending carving, below (Photos: Katie Worthington by courtesy of Stonewest Ltd)

The fixing of this capital had many complications. In particular the replacement section was top heavy and inclined to tilt forward. However, by accurately cutting the stone and leaving only narrow gaps for mortar beds (in this case 5mm) tilting could be prevented, as the stones above it and below would trap it in position once it was in place.

In order to create as secure a fixing as possible, a horizontal notch was cut into the back face of the opening to help interlock the new stone with the existing structure. In addition, stainless steel 316 grade threaded dowels were used to pin the new stone in place. The dowels were secured by drilling three dowel holes, two at the top and one at the bottom in the back face of the existing capital and the new section of stone, so that the holes could be accurately aligned when the two sections were joined together. After clearing the dowel holes of dust, they were filled with an epoxy resin. The stainless steel threaded dowels were then quickly inserted into the dowel holes of the existing capital. Time is of the essence as the resin can set in as little as five to ten minutes in hot weather.

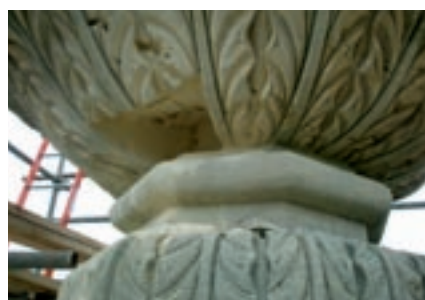
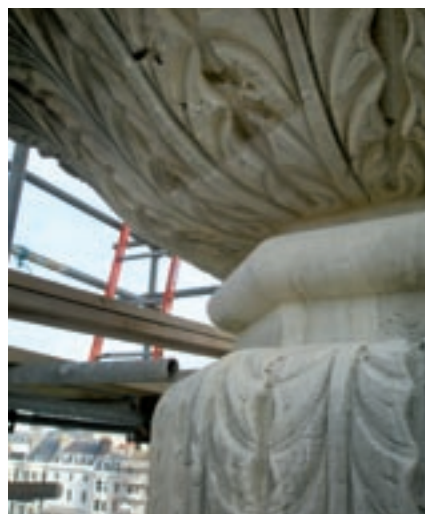
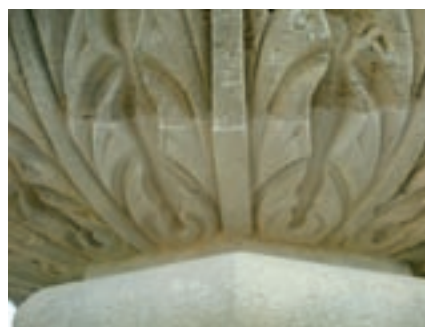
An indent repair at the Royal Pavilion, Brighton, showing the hole in the underside of one of the palm leafed capitals after cutting out the damaged section (left) and the repair (right). The detail (below) of the work before pointing shows more clearly that the lines of the new work copy the lines of the original carving, and are slightly proud of the weathered surface above.

The corroded stone was carefully cut out with an angle grinder and finished by hand tools so as not to damage the surrounding stones. This enabled straight lines to be produced between the leaves, aiming to be symmetrical where possible and 'level', while following their general shape. The resulting indent was shaped like an inverted triangle, with the point at the bottom.

After securing the stone in position, leaf shapes were drawn directly onto its face, accurately following the shape of the surrounding leaves, and these shapes were then carved in situ. Because of their palm tree form, the Royal Pavilion's stone leaves fan out vertically and are fuller at the top, so the tips of the leaves are bigger than the bottom. They loosely resemble an inverted triangle, although the edges of the leaves are rounded and contoured.

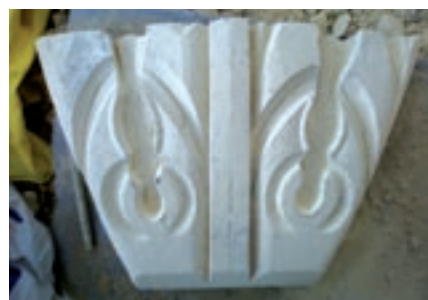
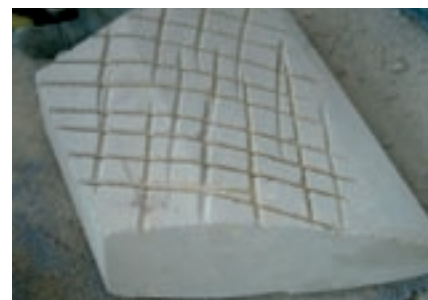
Detail of the new carving and its back after being 'keyed up' with an angle grinder (Photos: Katie Worthington, by courtesy of Stonewest Ltd)

The stone then had to be 'keyed up', a process which gave it extra grip. This involved making cuts with an angle grinder (traditionally a hammer and chisel would have been used to create pits and punch marks) on the adjoining joints into which the mortar engages itself. A bed height of 5mm was prepared using a 'St Paul's mix', a proprietary mortar which sets hydraulically – that is to say, without the need for air – enabling it to set deep within the structure where there is insufficient air for lime to carbonate. (Ordinary non-hydraulic lime mortars need atmospheric carbon dioxide to set.) It also increases the strength of the mortar, enabling it to take the weight of the stone in compression without any large aggregate particles.

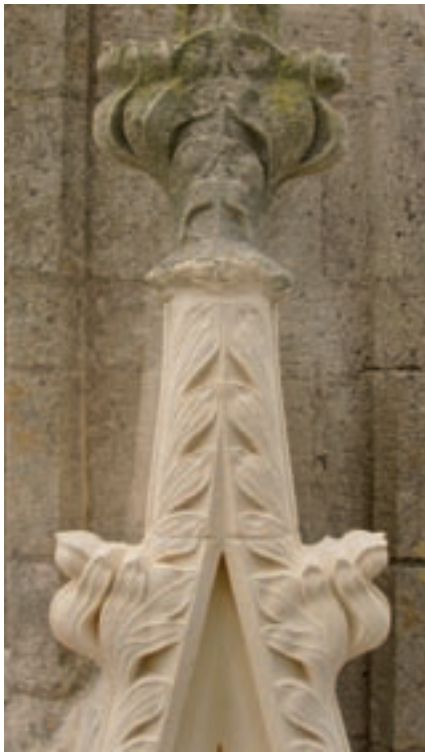
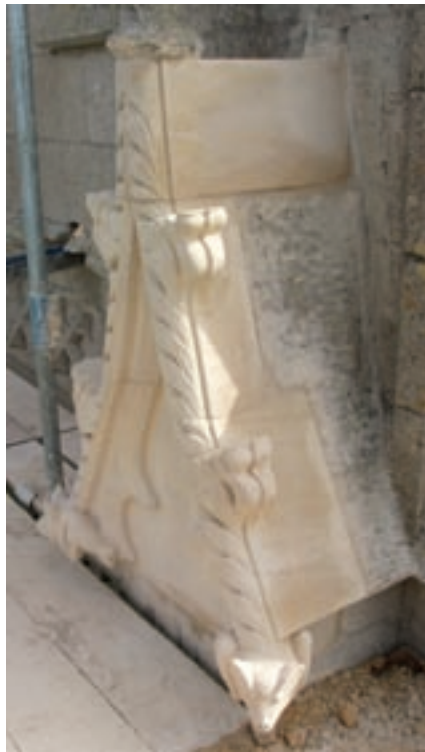
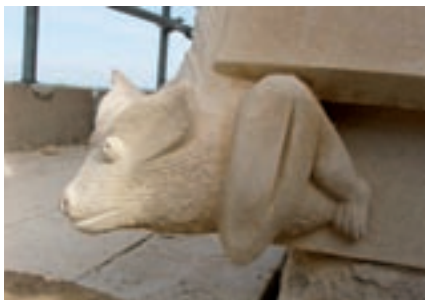
Details of the buttress repairs at Moulton, simply fixed with mortar joints and stainless steel dowels between blocks, and interlocked with the existing stonework behind to prevent it toppling forward (Photos: Katie Worthington, by courtesy of CEL Ltd)

Of course, not all jobs are as tricky as those at the Royal Pavilion or St Paul's. At the parish church of Moulton in Lincolnshire, for instance, fixing the new carved stonework for the buttresses was fairly straightforward. Originally constructed with simple, square joints, the buttresses comprised of three gable stones sitting on a large bottom bed and attached to the wall behind, with a free standing finial on top. As a result there was room to move the angle grinder freely from left to right when cutting out the badly weathered and crumbling stonework, unrestricted by stones on either side. It was then simply a matter of reconstructing it using new carved replacements placed one on top of another, with the aide of a block and tackle for the heavier stones.

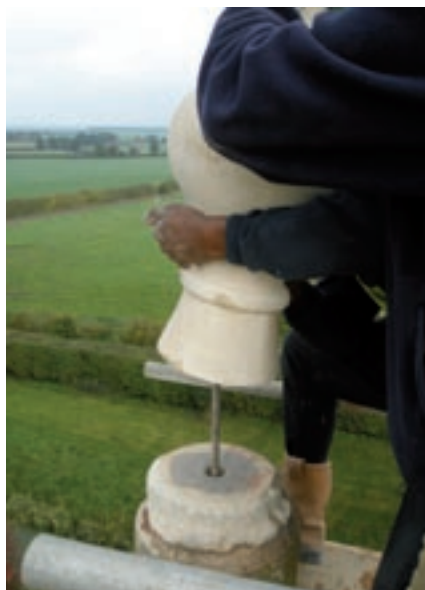
Lowering a heavy stone finial onto a dowel (Photo: Katie Worthington, by courtesy of CEL Ltd)

Finials are even easier to repair or replace, as they are completely free standing with no stones on top or, in most cases, surrounding them. When fixing the finial capitals in London City Cemetery, for example, it was possible to hold the finial above a dowel (already fixed to the top of the adjoining pier stone) and slide down. As these finials were small in size they required only one pin in the centre – in this case a stainless steel threaded dowel fixed in epoxy resin.

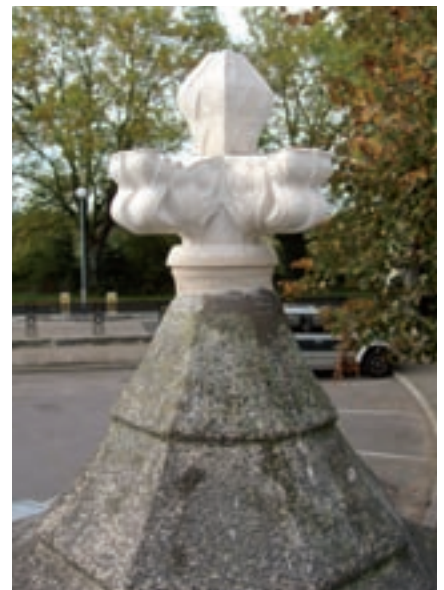
A finished finial in position at London City Cemetery (Photo: Katie Worthington, by courtesy of Stonewest Ltd)
