# of Wellington Arch

Like an early Christmas present, Wellington Arch at Hyde Park Corner, London, was 'unwrapped' in November and given a spectacular dawn display of lights and music.

For more than a year the famous Neoclassical Portland limestone Arch designed by Decimus Burton in 1825 to celebrate Wellington's victory over Napoleon had been hidden behind English Heritage screens.

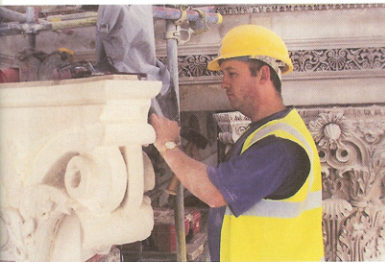
Stonewest carver Dave Baker carving a one tonne piece of Portland stone that has replaced the top part of a Corinthian capital on a pillar on the south-east elevation.

The upper half of a Corinthian capital on a pillar on the south-east elevation had to be completely replaced, ensuring the one tonne replacement stone was of high enough quality to take the ornate and heavily enriched carving required.

One of Stonewest's carvers, Dave Baker, spent 10 weeks producing the capital and
